Property Inspection Report

Prepared for: Gretel Baumgartner

1126 Morrissey Blvd

08/02/2010

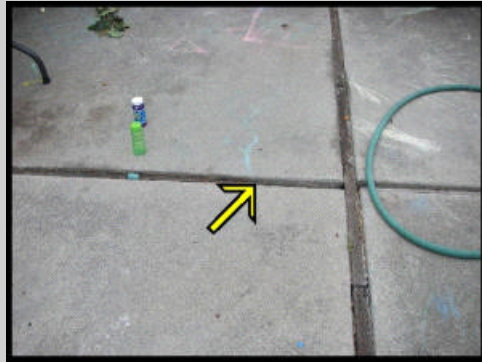
Common cracks were noted on the patio. We recommend sealing the cracks to prevent further erosion.

The wood between the pieces of concrete at the patio were deteriorated. We recommend replacement as this may present a tripping hazard.

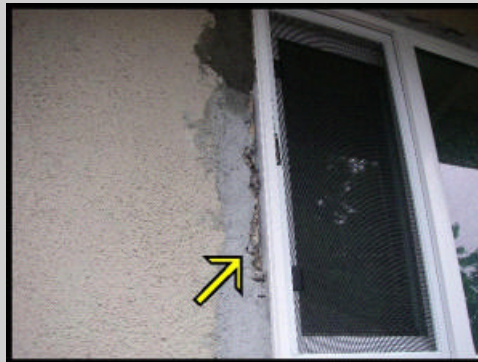
General condition appeared serviceable with the exception of the following item(s): Damage was noted to the siding at the front of the home. We recommend repair. Refer to a qualified termite report for further information.

The walls are clad with stucco which ends below the soil level. Current standards call for stucco to end above the level of the soil. This helps deter pests and moisture wicking. Upgrades are recommended.

Cracks are noted in the stucco. These appear to be common cracks. We recommend sealing the cracks with painters calking to prevent moisture intrusion.

Damage was noted to the stucco around the hallway bathroom window at the right of the home. We recommend repair to prevent moisture intrusion.

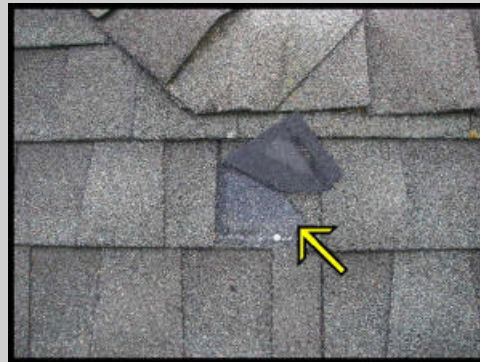
5.4 COMPOSITION ROOF CONDITION:

General condition appeared serviceable with the exception of the following item(s): One damaged or missing shingle was visible on the roof. We recommend repair or replacement of this shingle to prevent moisture intrusion.

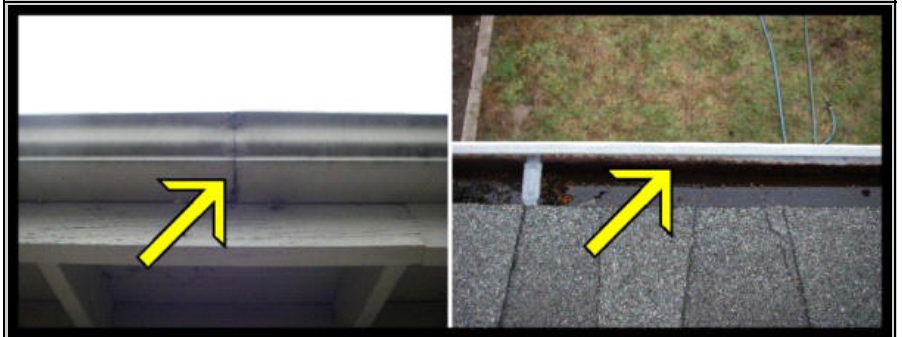
5.9 GUTTER TYPE & CONDITION:

Full. The general condition appeared serviceable with the exception of the following item(s) listed below. Rusting viewed. This is typically an indication that the gutters are older. We recommend monitoring. Anticipate the need for replacement in the future.

Gutter at the right of home appears to leak at the seam. We recommend repair.

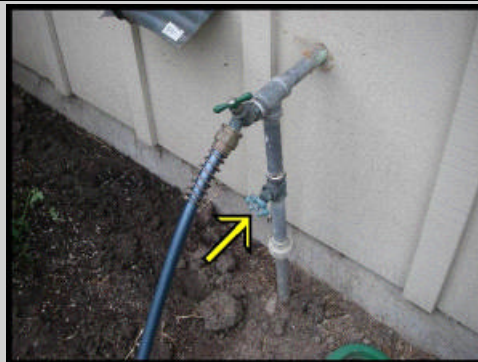
6.1 LOCATION-SIZE-MATERIAL:

Front of home.

Valve not tested. General condition appeared serviceable with the exception of the following item(s): Aging galvanized plumbing was noted. Older galvanized plumbing tends to rust from the inside causing the internal bore to be reduced over time. Anticipate the need for repair or replacement of the plumbing system in the future.

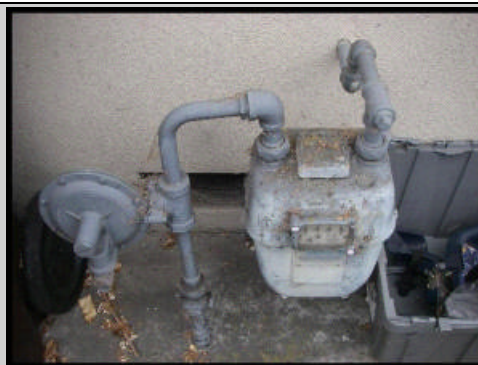
6.9 LOCATION:

Gas meter was located on the left side of the home. We recommend the installation of a gas meter shut off wrench at the meter so the gas can be turned off in the case of an emergency.

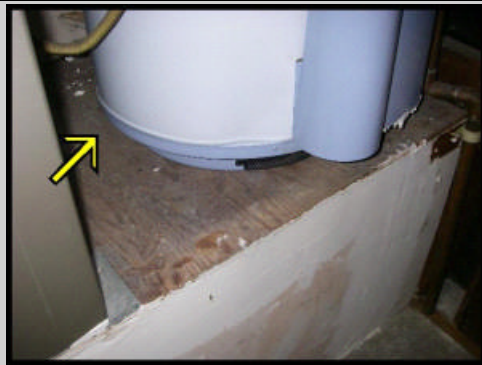
6.14 CONDITION:

The general condition appears serviceable with the exception of the following item(s) listed below. The floor of the water heater compartment appeared to be sagging. This can be caused by the weight of the unit or a moisture condition. We recommend repair or replacement.

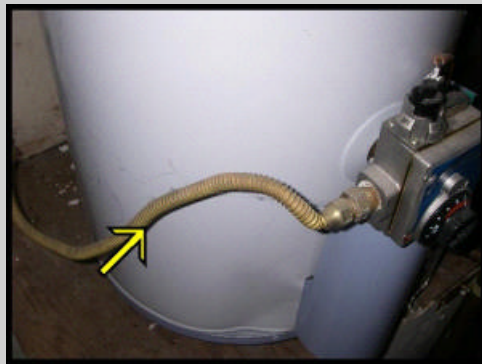
6.16 PLUMBING:

Pressure relief valve was noted, not tested. A water shutoff valve was installed. The unit is plumbed with a flexible brass type gas line. These type of lines have been known to deteriorate over time and are no longer used. We recommend upgrading the gas line to the unit for safety enhancement.

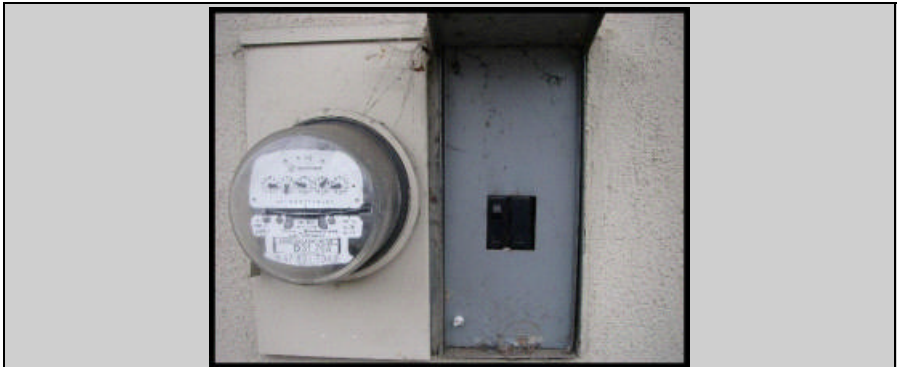
7.6 MAIN PANEL & SHUT OFF LOCATION:

Located at the exterior left of the home.

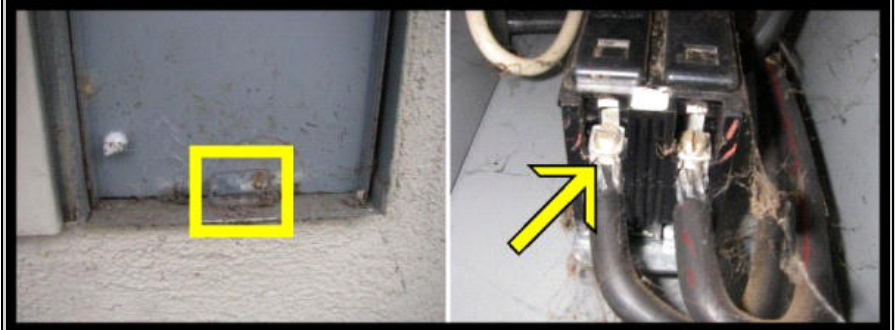
7.7 MAIN PANEL CONDITIONS:

Grounding system is present. General condition appeared serviceable with the exception of the following item(s): The dead front cover is a type which does not have screws to keep the dead front cover in place. This can be a safety hazard for children who could open the panel. We recommend the installation of a lock or screws which will make the removal of the dead front cover difficult for children.

We recommend the installation of antioxidant paste at each of the aluminum wire to breaker connection.

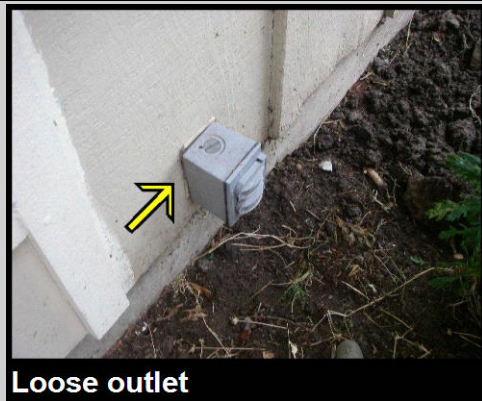
7.13 DAMAGED / LOOSE OUTLETS:

Loose outlet

Loose outlet(s) were noted at the following location(s): front. This is a potential safety hazard. We recommend repair.

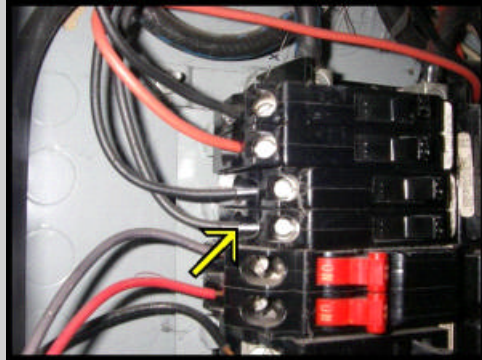
7.15 BRANCH WIRING TYPE:

Copper. Aluminum (220 volt OK). Aluminum wiring was noted at the 110 volt circuits. Aluminum wiring tends to expand and contract more than copper wiring which can cause loosening at connectors which were originally designed for copper wiring. These loose connections can cause a spark and possibly a fire. We recommend that all aluminum wiring be checked by a qualified licensed electrician familiar with aluminum wiring.

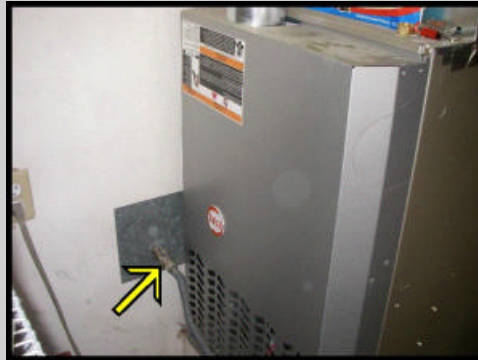
General condition appeared serviceable with the exception of the following item(s): We were unable to remove the cover due to gas line obstructing the removal. Correction is recommended and further inspection.

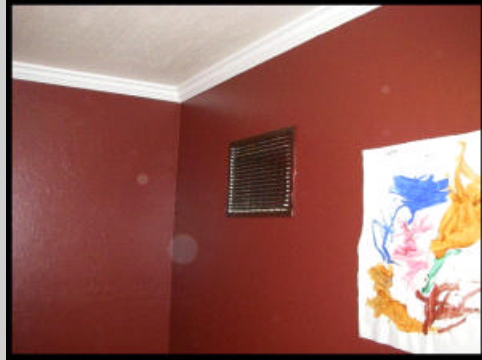
8.12 RETURN AIR REGISTER:

Return air register noted in the kitchen. This is an improper installation. We recommend moving the return air register to an open central area of the home to ensure proper air flow back to the furnace.

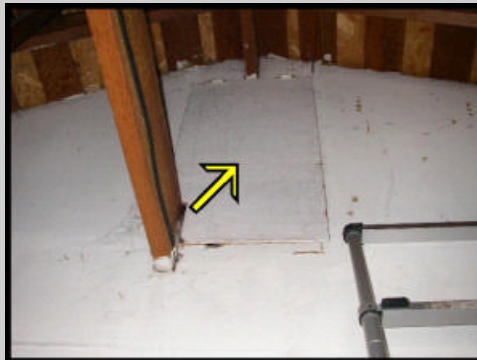
9.3 WALL CONDITION:

Walls of the garage were not fully visible due to stored items. The door to the attic from the garage was made of combustible materials. This is a potential safety hazard. We recommend installing a door to the crawlspace which is fire rated.

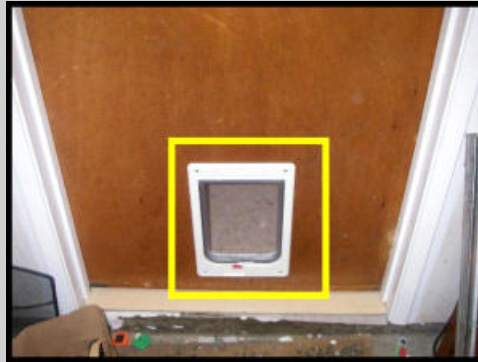
9.7 CONDITION:

Self closer was functioning properly. General condition appeared serviceable with the exception of the following item(s): Pet door penetrates through the door. This compromises the fire rating of the door. This is a safety hazard. Correction is recommended. No threshold was noted at the interior garage door. We recommend installing a threshold to prevent unwanted pests from entering.

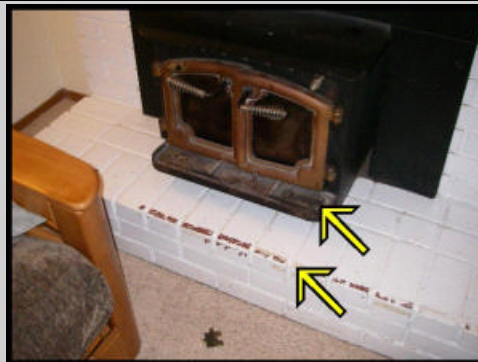
10.24 HEARTH CONDITION:

There did not appear to be a minimum of 16" from the burn area / door to combustible materials. The hearth should extend a minimum of 16 inches in front of the firebox / door. This is typical in several jurisdiction's. We recommend researching the county building requirements prior to the release of the inspection contingency. This is a fire / safety hazard. Correction is recommended.

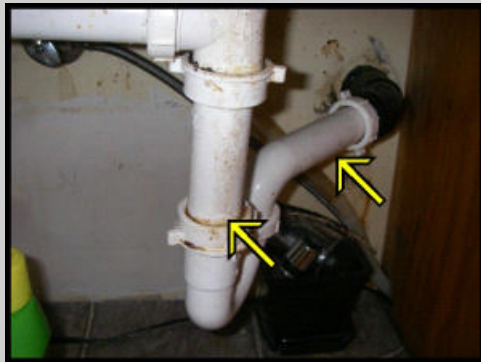
12.2 CONDITION:

Faucet appeared serviceable. The general condition appeared serviceable at the time of the inspection with the exception of the following item(s) listed below. Waste plumbing below the sink was leaking. We recommend repair to the drain line.

The drain line appears to flow uphill in one section below the sink. We recommend repairs to allow the line to flow downhill. We recommend further evaluation and repairs by a licensed plumber.

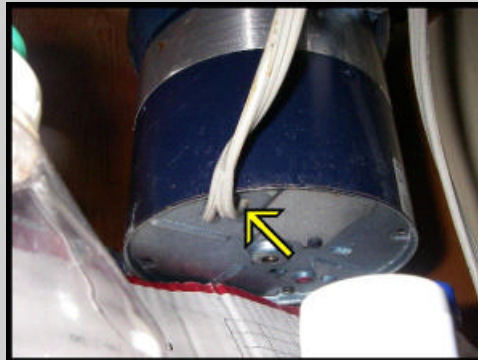
12.10 CONDITION:

General condition appeared serviceable with the exception of the following item(s): Clamp was missing on the wire below the garbage disposal. This is a potential safety hazard. Correction is recommended.

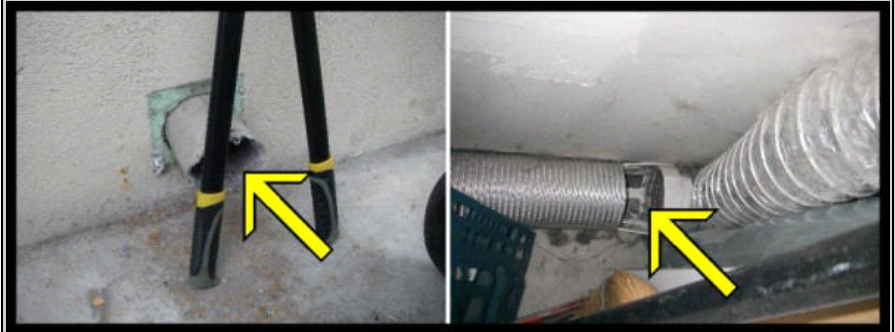
General condition appeared serviceable with the exception of the following item(s): The dryer vent was disconnected behind the unit. Correction is recommended.

The vent cover at the exterior termination of the dryer vent pipe was missing. We recommend installing a proper vent cover to prevent unwanted pests and moisture damage.

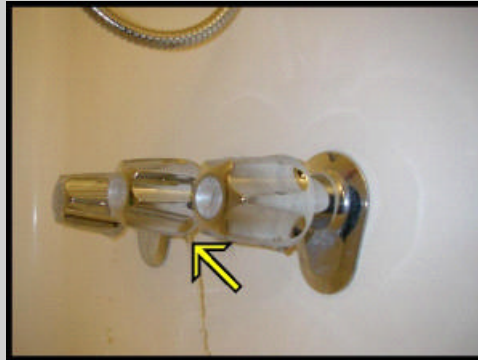
14.16 TUB/SHOWER PLUMBING FIXTURES:

Drain appeared serviceable. Shower head appeared serviceable. Shower head was labeled 2.5 GPM and appears to be low flow. The general condition appeared serviceable with the exception of the following item(s): Leakage was noted at the faucet handles. We recommend repair or replacement of this fixture by a licensed plumbing contractor.
